SUBJECT: Transmittal Memo – Compliance Monitoring Report

FACILITY NAME: Louisiana Land and Water Company, Inc.
Woodland Acres STP #2

NPDES Compliance Inspection Report

LPDES Permit Number: LAG540021

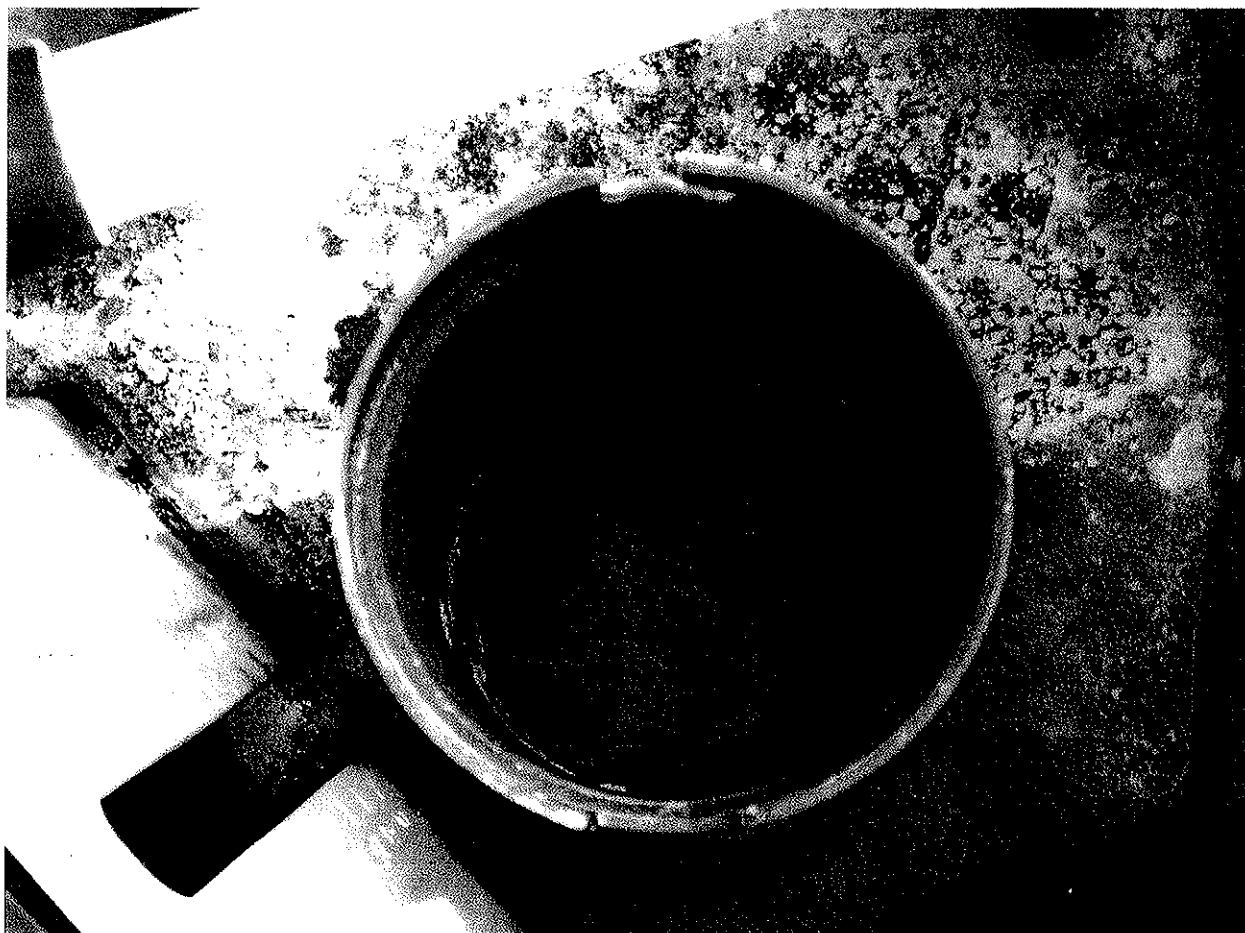
Subject: No chlorine in tube

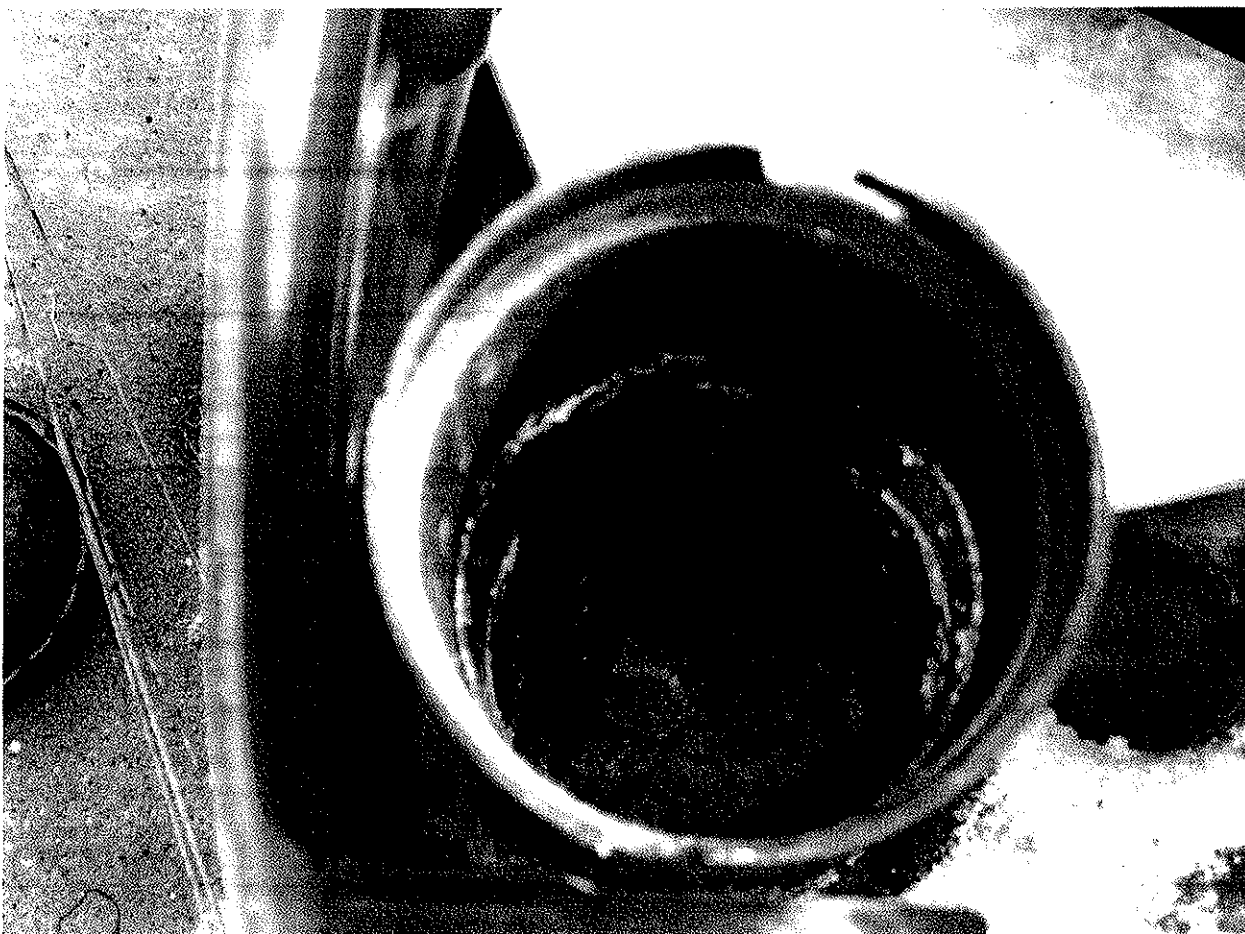
Subject: No chlorine in tube

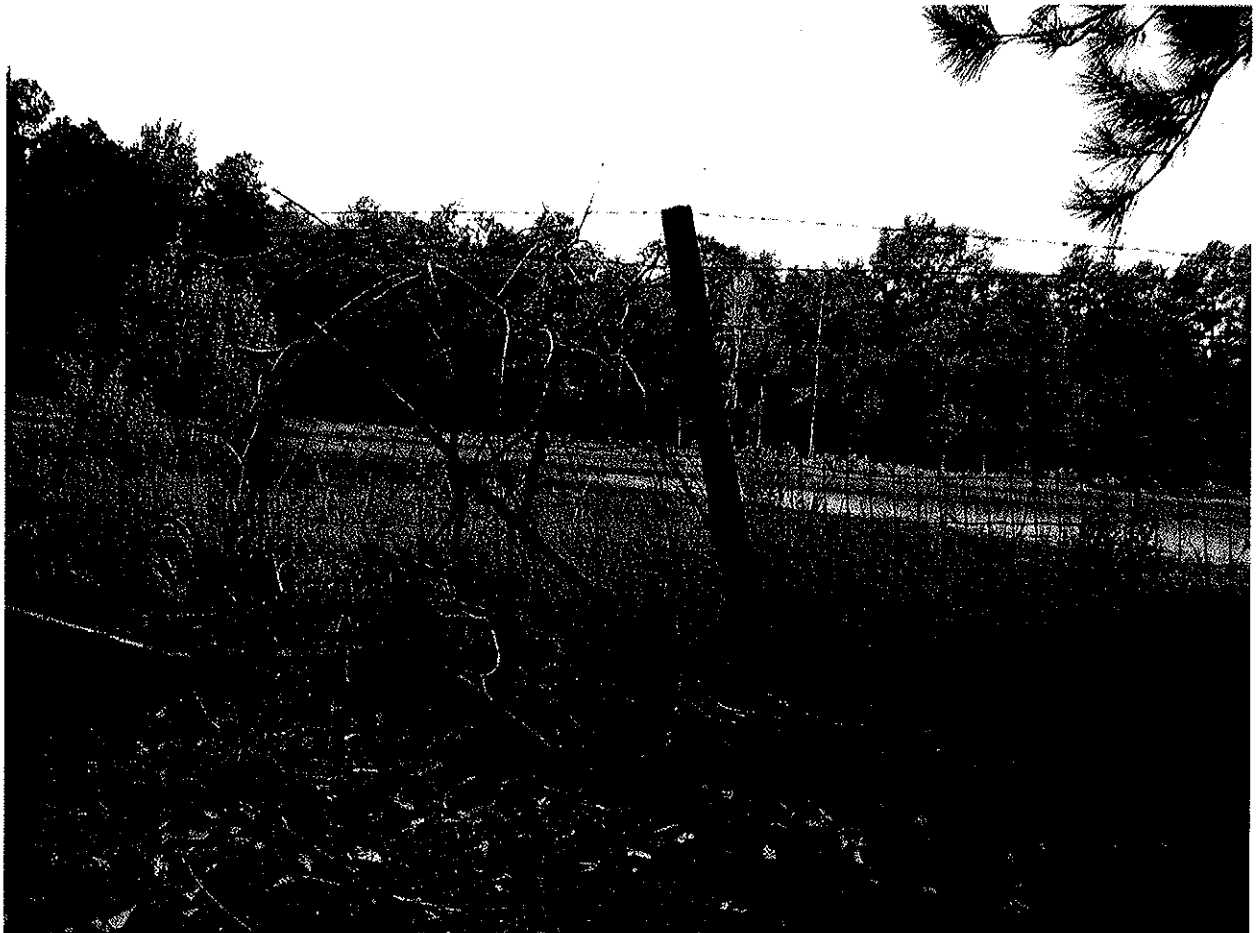
Subject: Hole in the fence leading to the one cell oxidation pond

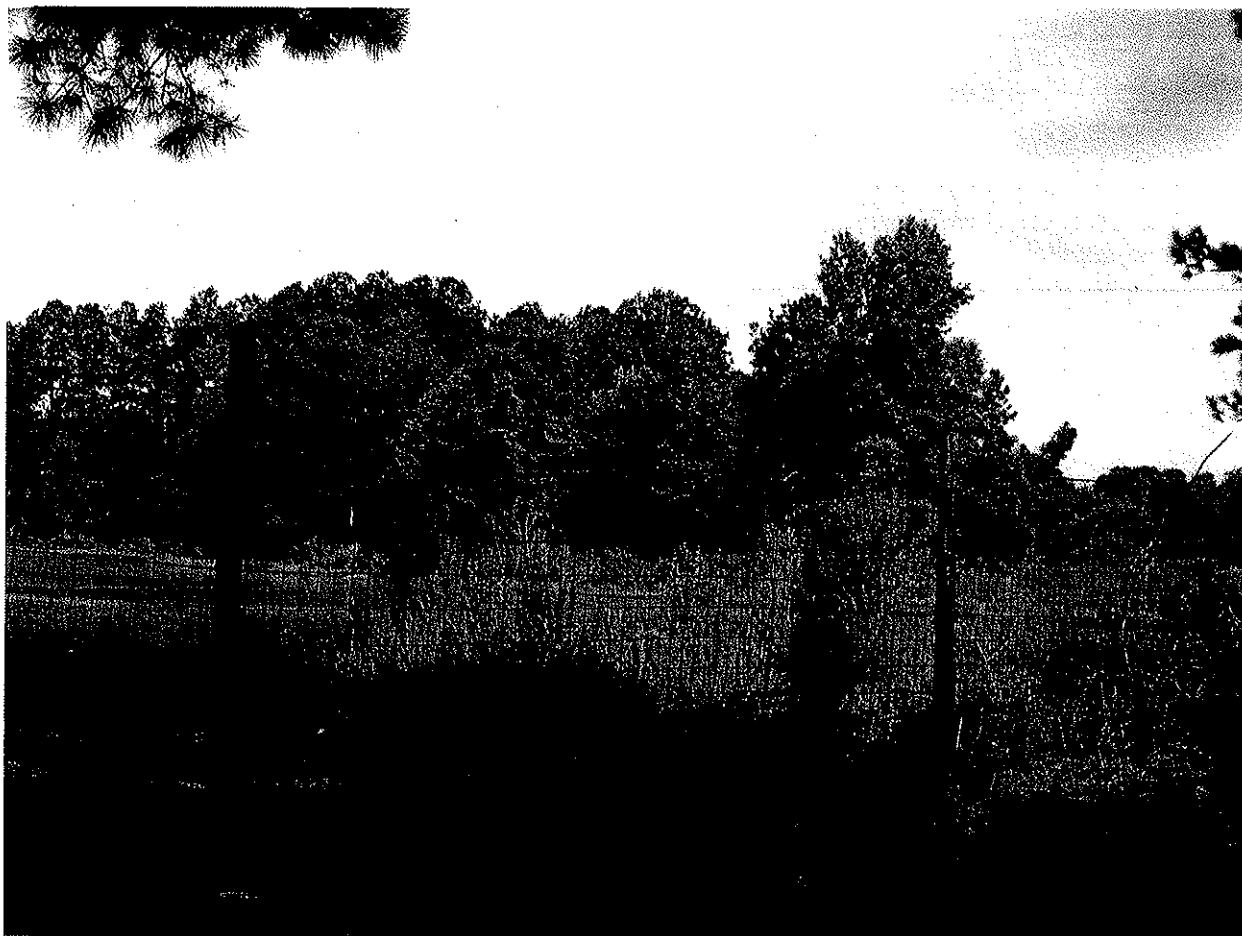
Subject: One cell oxidation pond; Overgrown pond bank

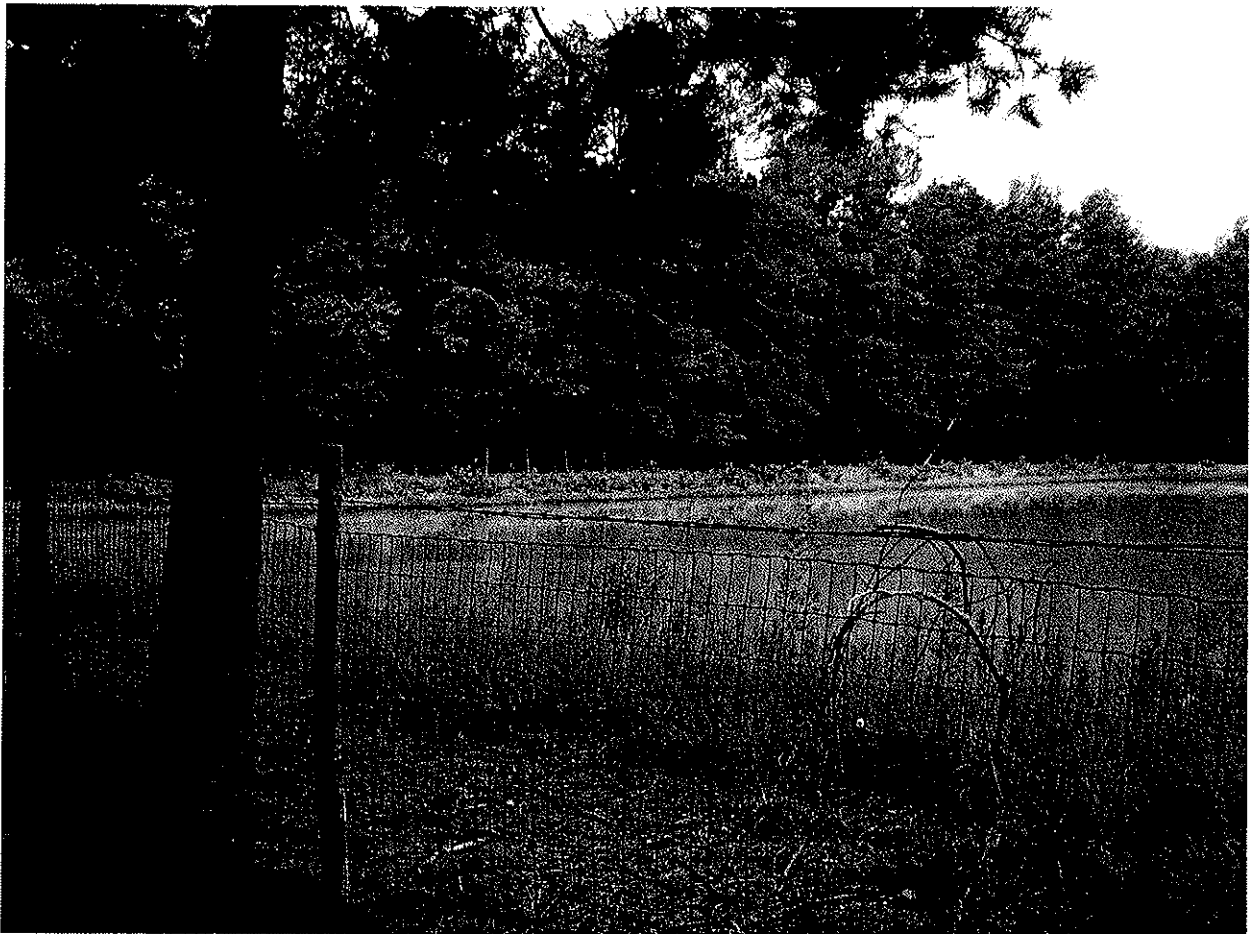
Subject: One cell oxidation pond; Overgrown pond bank

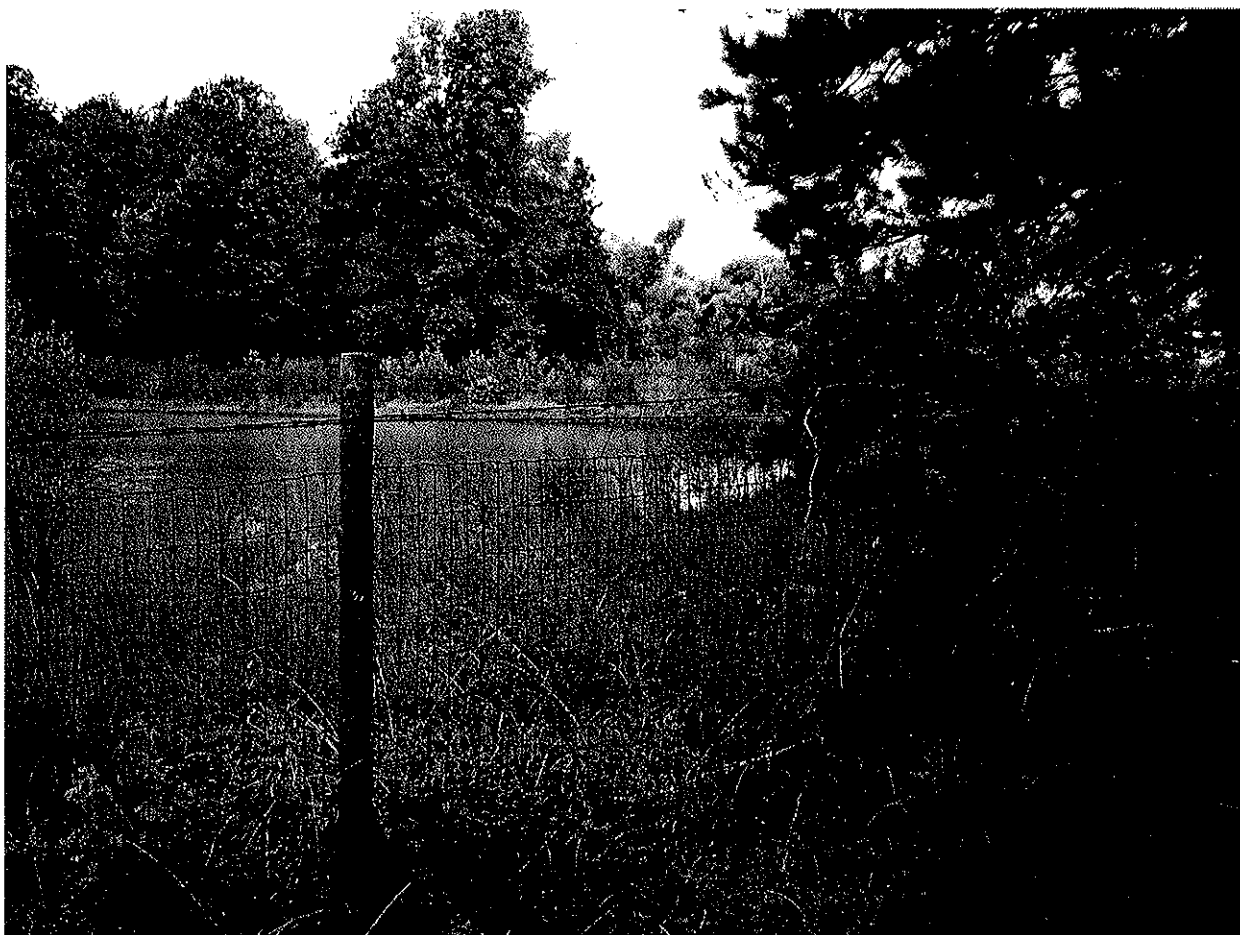
Subject: One cell oxidation pond; Overgrown pond bank

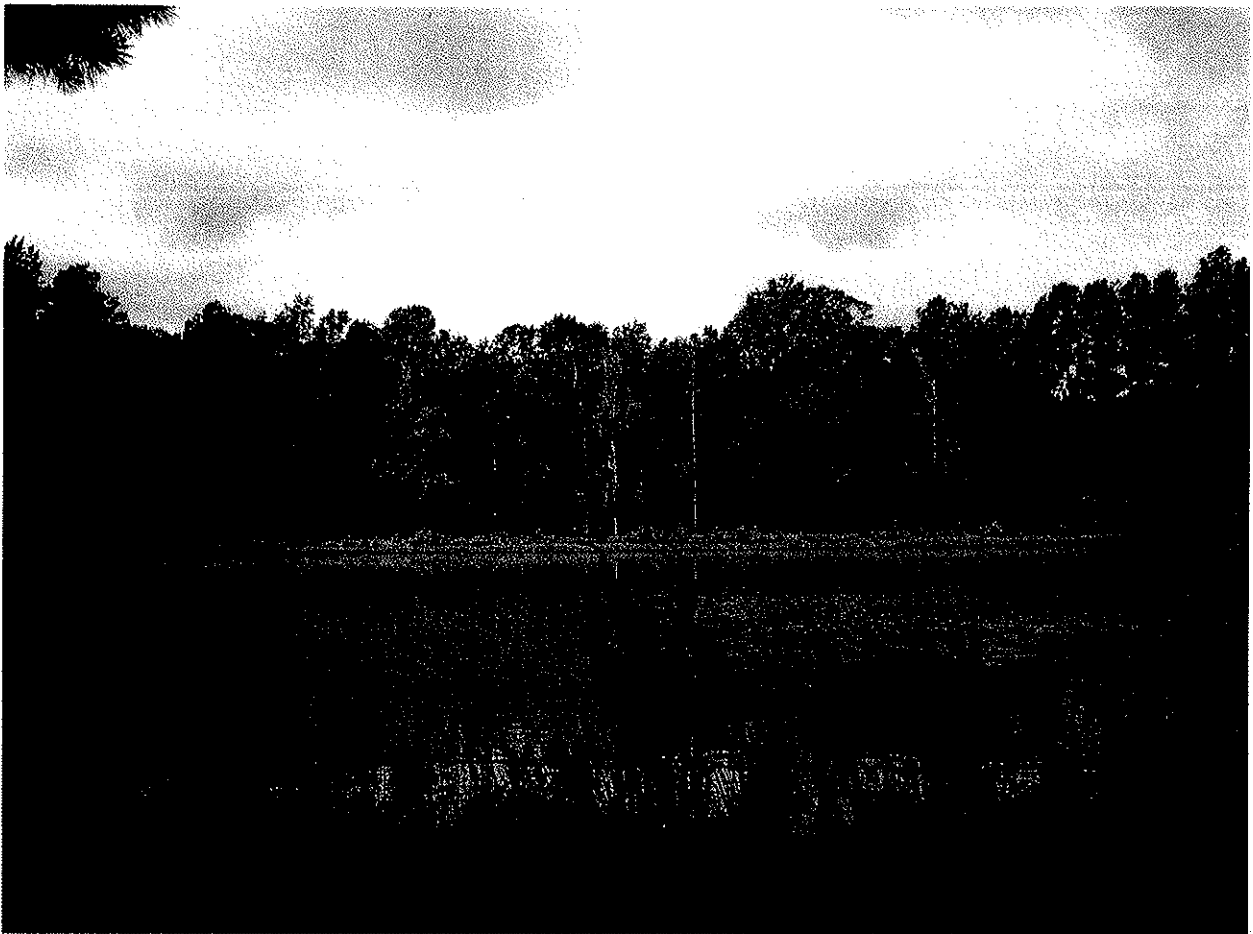
Subject: One cell oxidation pond; Overgrown pond bank

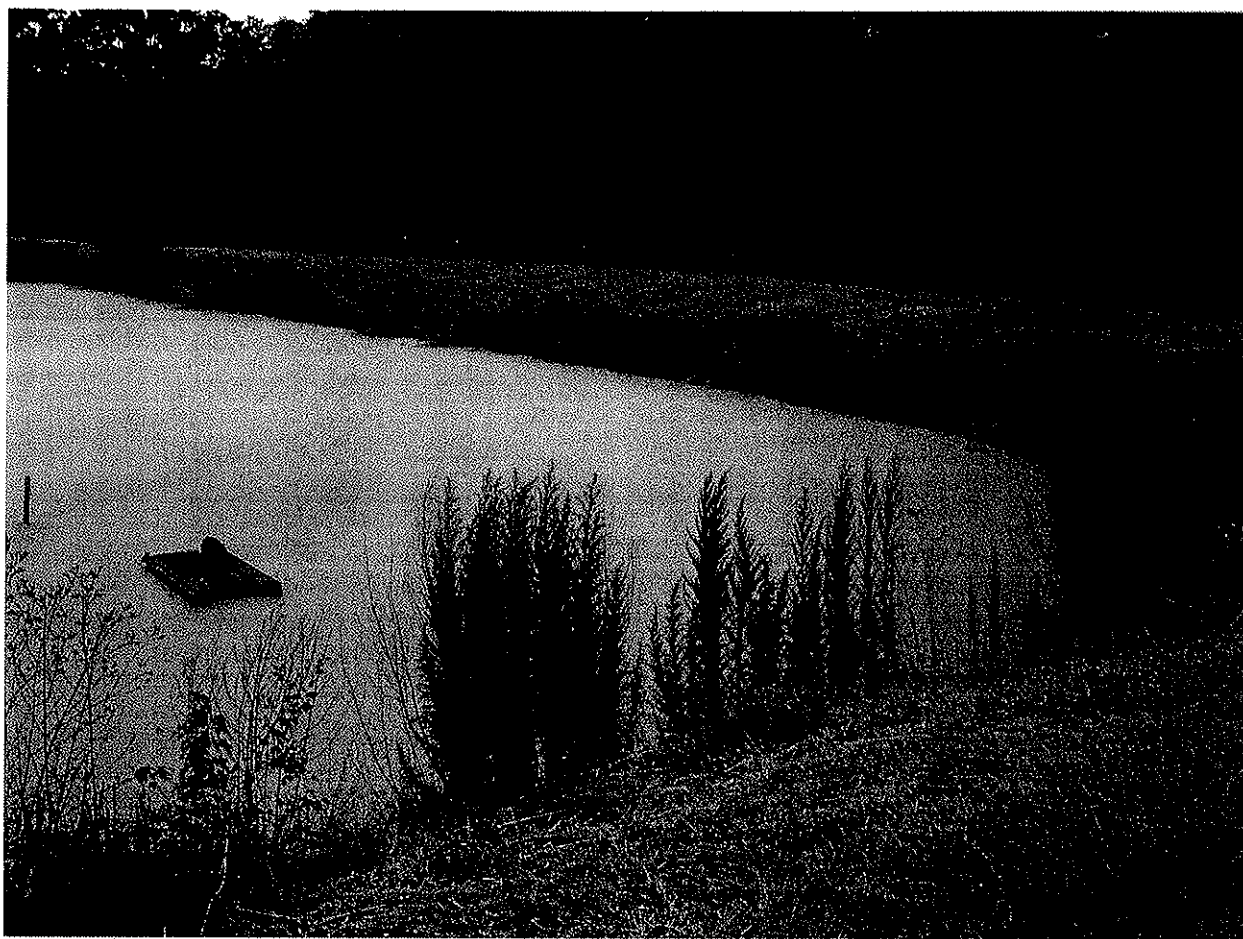
Subject: Failed aerator; Overgrown vegetation on the pond banks

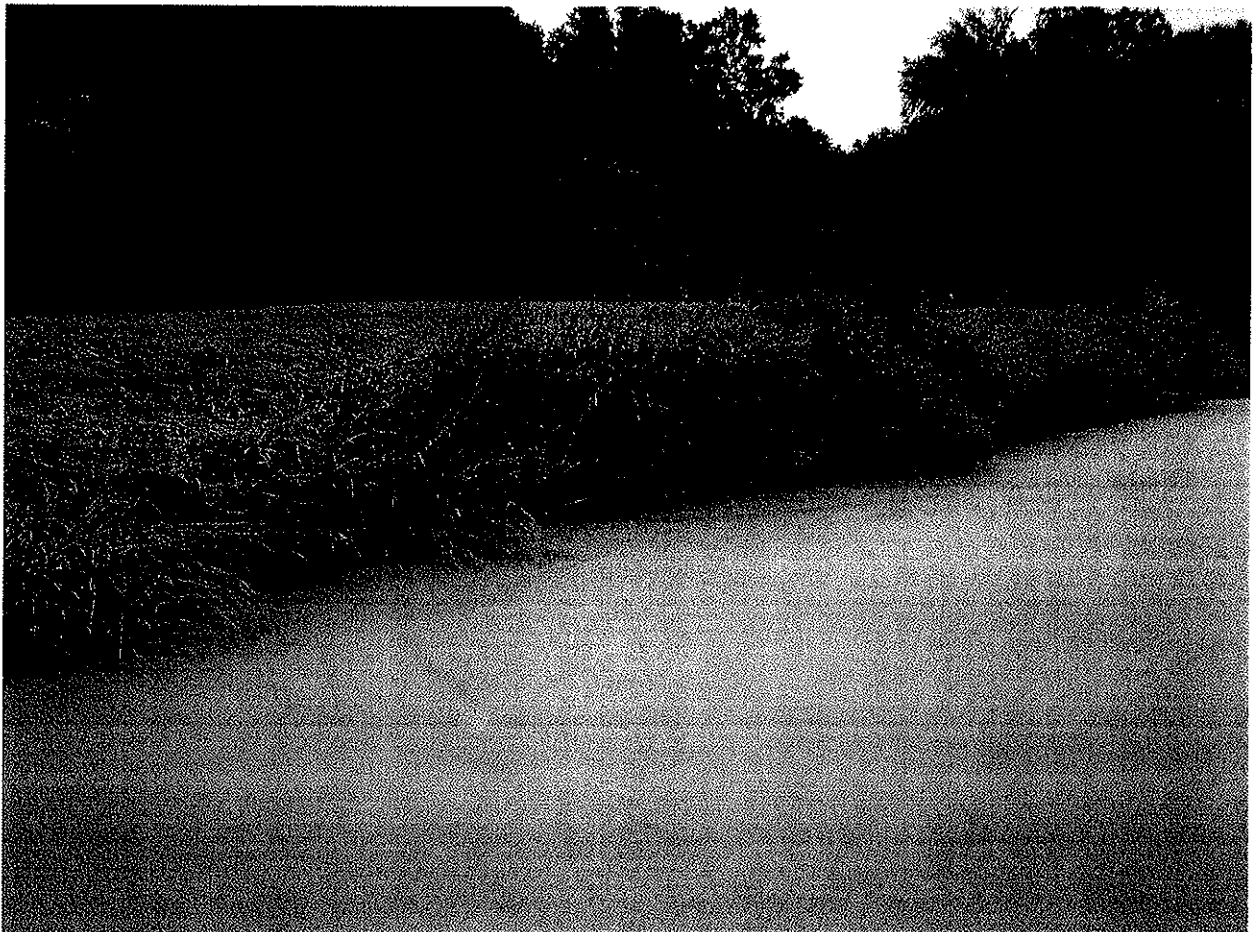
Subject: Overgrown vegetation on the pond banks
